Olive Switching Station
13355 San Fernando Road
Los Angeles
Los Angeles County
California

HISTORIC AMERICAN BUILDINGS SURVEY
OLIVE SWITCHING STATION

HABS NO. CA-2664

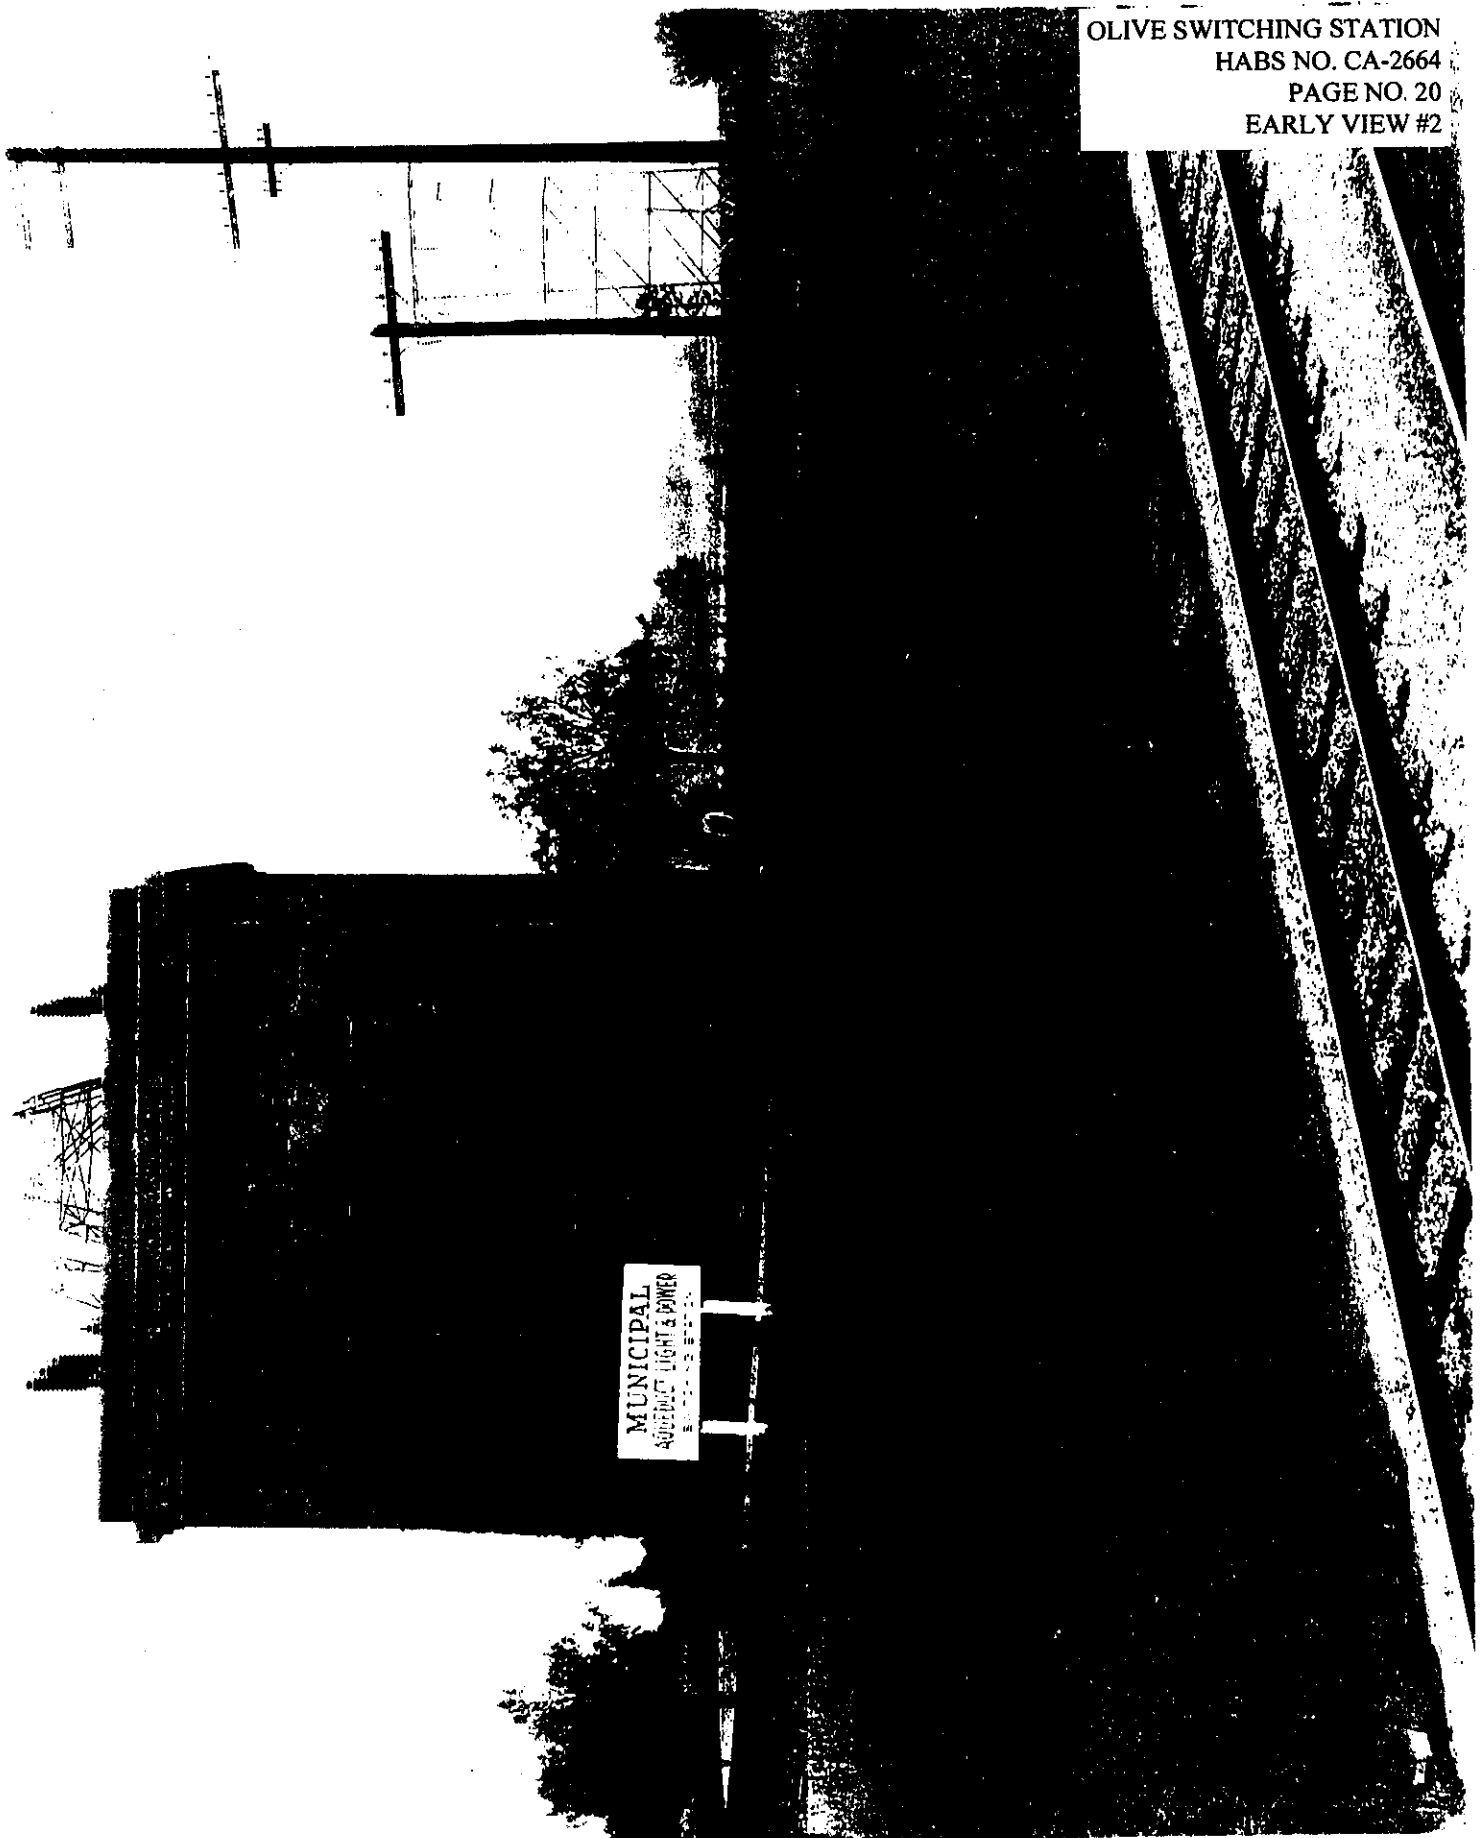
OLIVE SWITCHING STATION
HABS NO. CA-2664
PAGE NO. 20
EARLY VIEW #2

Photograph, Sylmar Switching Station [Olive Switching Station], Photographer unknown, LAWDP 3-1684, Undated [circa 1930]. Copy negative in DWP Photograph Collection, Department of Water and Power.

Photograph shows east side of the station; only a portion of the roof transmission towers are visible; transmission tower possibly for San Fernando Power Plant is seen. A sign in front of the structure reads, "Municipal Aqueduct Light & Power Switching Station."
